AFRL-RX-WP-TP-2011-4299

**OBSERVATIONS ON THE ROLE OF HYDROGEN IN FACET
FORMATION IN NEAR- α TITANIUM (Preprint)**

A.L. Pilchak

MAY 2011

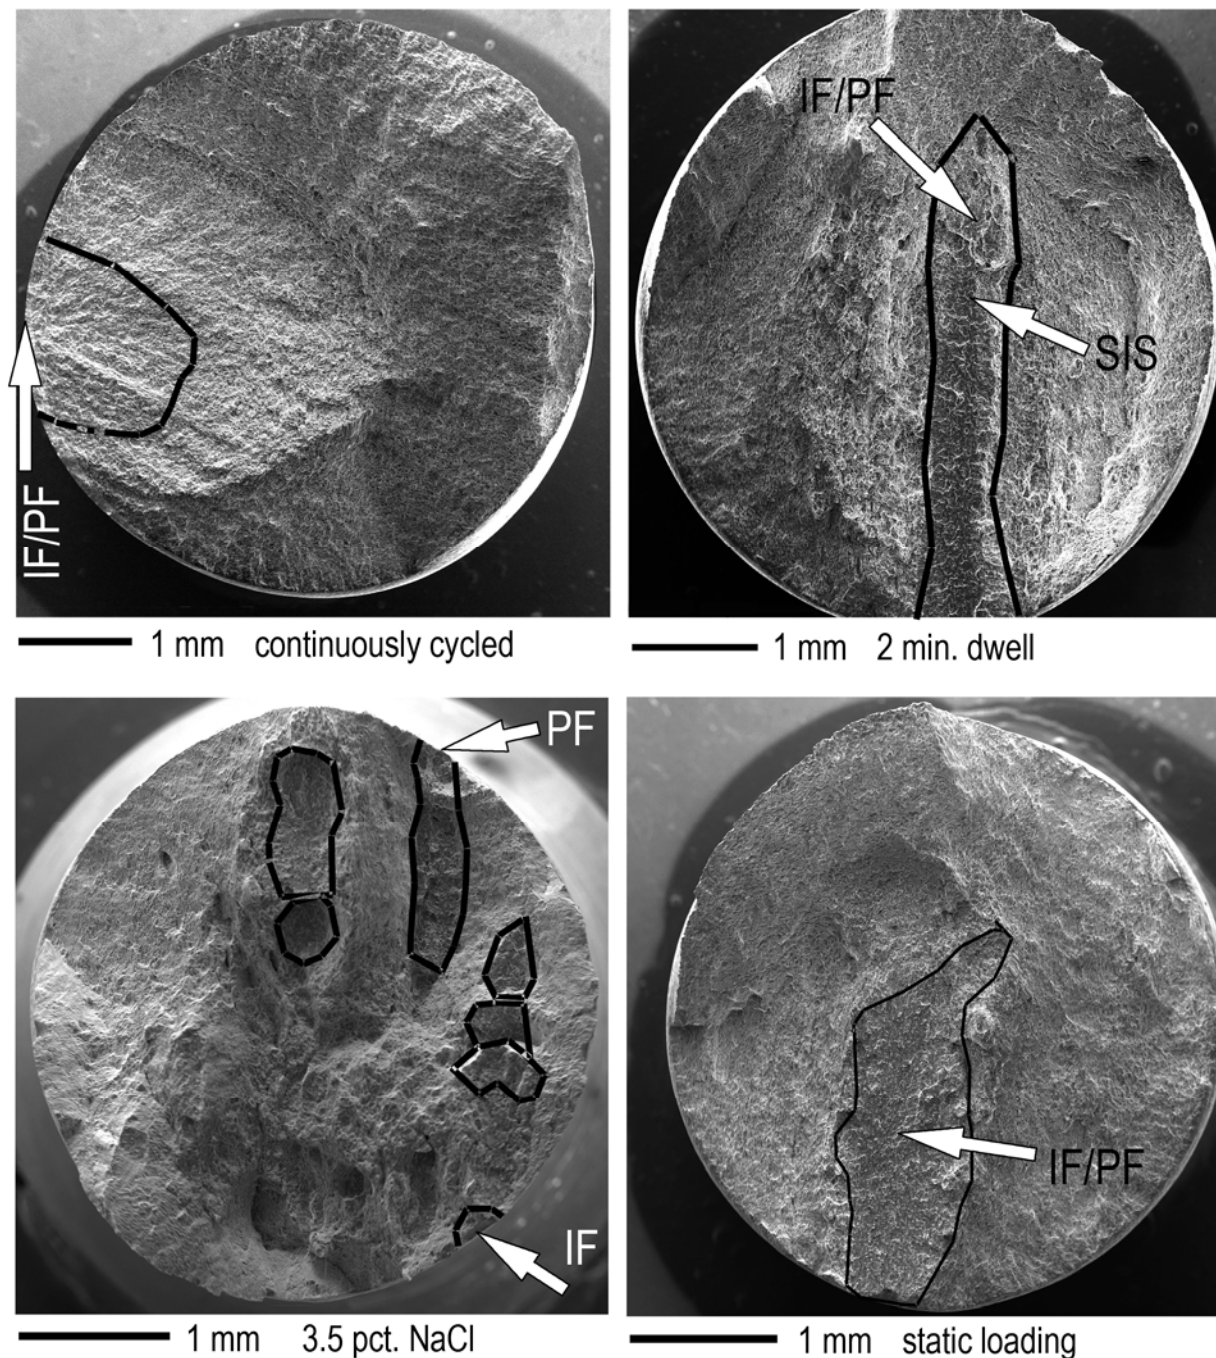
The fracture surfaces were all qualitatively similar in the sense that they contained facets and features, like dimples and shear lips, typically associated with overload failure. The regions between faceted growth and overload fracture were considerably different among the various specimens due to the different loading

In contrast, the dwell fatigued specimen exhibited subsurface crack initiation and had a considerably larger faceted region that was on the order of 250 μm wide and extended approximately 3 mm from the circumference of the specimen into the gauge section. Similar elongated faceted regions were observed on all of the statically loaded specimens suggesting that the formation of such regions is unique to sustained loading. It is noteworthy that the length scale, aspect ratio and physical orientation of these elongated faceted regions is consistent with that of the microtextured regions observed in the as-received bar material (Figure 5). This correlation has possibly been overlooked in the past because the microtextured regions in the $\alpha + \beta$ forged pancake material analyzed by Sinha et al. [28] were approximately equiaxed in shape. In addition, Sinha et al. [28] did not explicitly identify where in the faceted region the crack started and thus a preferential growth could not be identified. Uta et al. [17] have studied the fracture surface specimen that failed during dwell fatigue loading that had elongated bands of microtexture similar to the material studied here. However, the authors used a 30 s dwell period and did not observe such a strong preference for the

Figure 6. Low magnification SEM images of the fractured specimens. The faceted regions on each specimen are enclosed by black lines. The locations of the initiation facets (IF) and propagation facets (PF) discussed in more detail below are identified on each fracture surface. The location of a secondary initiation site (SIS) on the dwell fatigue specimen is also shown.

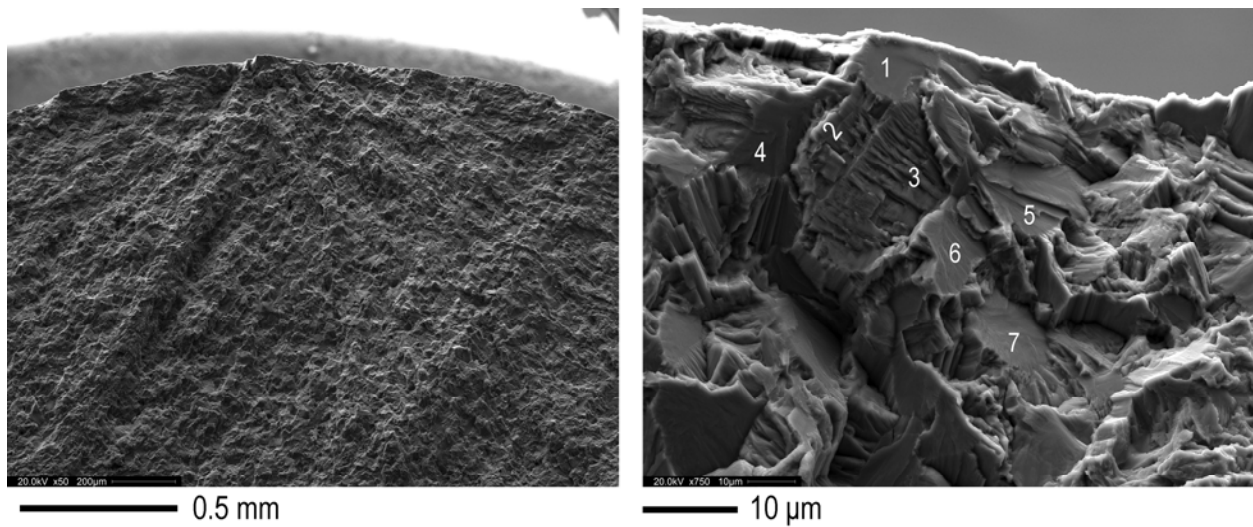
There was a single clearly identifiable fatigue crack initiation site in the specimen loaded by continuous cycling. This region is shown at two levels of magnification in Figure 6 and Figure 7. Although there was no large, continuous faceted region consistent with the microtextured regions in this specimen there were many facets were observed at the crack initiation site (Figure 7). While some of the facets directly bordered one another, there were many locations separated by sharp, planar features such as those identified as numbers 2 and 3 in Figure 7. In the strictest sense, these could be called facets, but we reserve that term for the more planar features identified by the remaining numbers (1, 4, 5 and 6) that are formed by transgranular fracture through a primary α grain with a fracture plane nearer the basal plane than any other low index plane as will be shown later. Except for the initiation facet, there were markings on the facet surfaces that were indicative of the local crack propagation direction (Figure 8). Subsequent facet surfaces were observed to be progressively and continuously more rough with increasing crack length. In addition, the number of steps on the facet surfaces seemed to increase in density with each grain boundary encountered by the crack front. For the case of continuous cycling, this is related to the increase in the cyclic crack tip plastic zone size with increasing crack length [27] which results in a larger fracture process zone on each subsequent cycle. At high magnifications while utilizing the TLD, striations were occasionally visible on some facets. Two examples are shown in Figure 9 where, on the left, the striations resemble slip steps on the facet surface while, on the right, they resemble more conventional striations. At a crack length of approximately 100 μm , the spacing of these striations is on the order of 150 nm cycle⁻¹.

The spatial and crystallographic orientations of all the facets identified in Figure 7 (except for H2-1-7) were determined using the combined EBSD/quantitative tilt fractography technique. The results have been compiled in Figure 10 which shows the orientations of each fractured grain with respect to the loading direction and also with respect to the facet normal direction. A total of seven individual EBSD patterns were collected and indexed from the first grain to fracture (H2-1-1) while two patterns were collected from the remaining grains. Initiation occurred within a primary α grain that had its c-axis oriented 24° from the loading direction. The facet normal angle was 27° and the fracture plane was determined as being parallel to the basal plane for all seven indexed patterns within the resolution of the technique. The spatial and crystallographic orientations of this primary α grain initiation site are consistent with observations made on fatigue crack initiation facets in α grains in continuously cycled Ti-6Al-4V [29,30] and Ti-6246 [31,32] specimens with bi-modal microstructures. In addition, despite being near the surface of the specimen, the orientation of this grain is such that it could not have formed a slip band extrusion on the surface of the specimen as the only available $\langle a \rangle$ slip system which could intersect the specimen surface has nearly zero resolved shear stress.

Figure 7. Crack initiation site in the continuously cycled specimen in the as-received condition. Several facets are identified by the integers 1 through 7. The number, N, corresponds to the last digit in the facet serial number H2-1-N.

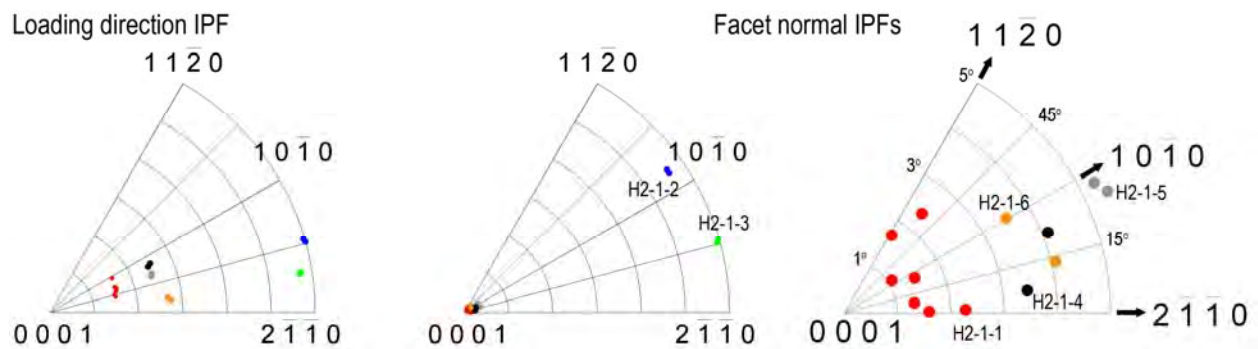
Two of the grains (H2-1-2 and H2-1-3) directly adjacent to the crack initiating grain have their c-axes nearly perpendicular to the applied loading direction. In this orientation, the maximum resolved shear stress is on the prismatic $\langle a \rangle$ slip systems and there is nearly zero resolved shear stress on the basal plane. While there are also suitably oriented $\langle c+a \rangle$ slip systems, the higher critical resolved shear stress of these systems [33] imply that the grains would tend to deform by prismatic $\langle a \rangle$ slip. Because these two grains did not fracture on a flat, continuous faceted plane, the average fracture plane was determined over several areas spanning $\sim 8 \mu\text{m}$ each on the fracture surface. After correcting for this average fracture plane

normal, the plane of fracture was determined to be near $\{10\bar{1}0\}$ for both grains. The average fracture plane normal for these regions was determined to be 41° (H2-1-2) and 25° (H2-1-3). The size, appearance and spatial orientation of these regions are consistent with the underlying microstructure being transformed β based on previous work conducted on bi-modal Ti-6Al-4V in which there was direct observation of the fracture surface and the underlying microstructure [30].

The remaining facets, H2-1-4 through H2-1-6, can be characterized as transgranular propagation facets through primary α grains. These facet normal directions made angles (in order) of 36° , 40° and 44° . The crystallographic plane of fracture was near the basal plane for all facets, however, there was a slight deviation from the basal plane observed for all specimens with facet H2-1-5 being the furthest, at an angle 5° . It is believed that these discrepancies can be attributed to errors introduced to the spatial orientation calculation by the increased facet surface roughness and the formation of steps as discussed in depth by Pilchak et al. [27]. Thus, all of these grains are in orientations that could have easily formed a slip band on the basal plane followed by cracking along that slip band.

Figure 10. Results from the facet crystallography analysis on the continuously cycled fatigue specimen. The IPF on the right is a magnified view of the region around 0001 in the center facet normal IPF (also note the change in scale for this IPF).

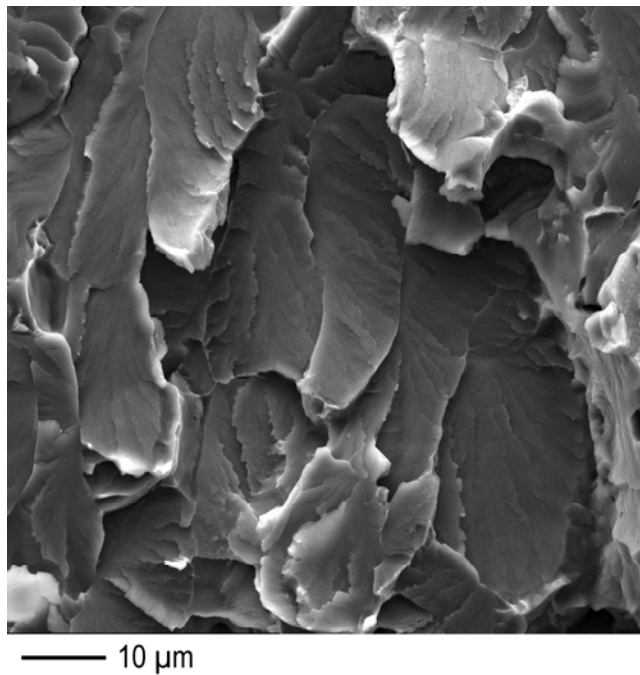
Figure 12. Typical facet appearance throughout the entire faceted region on the specimen statically loaded in air.

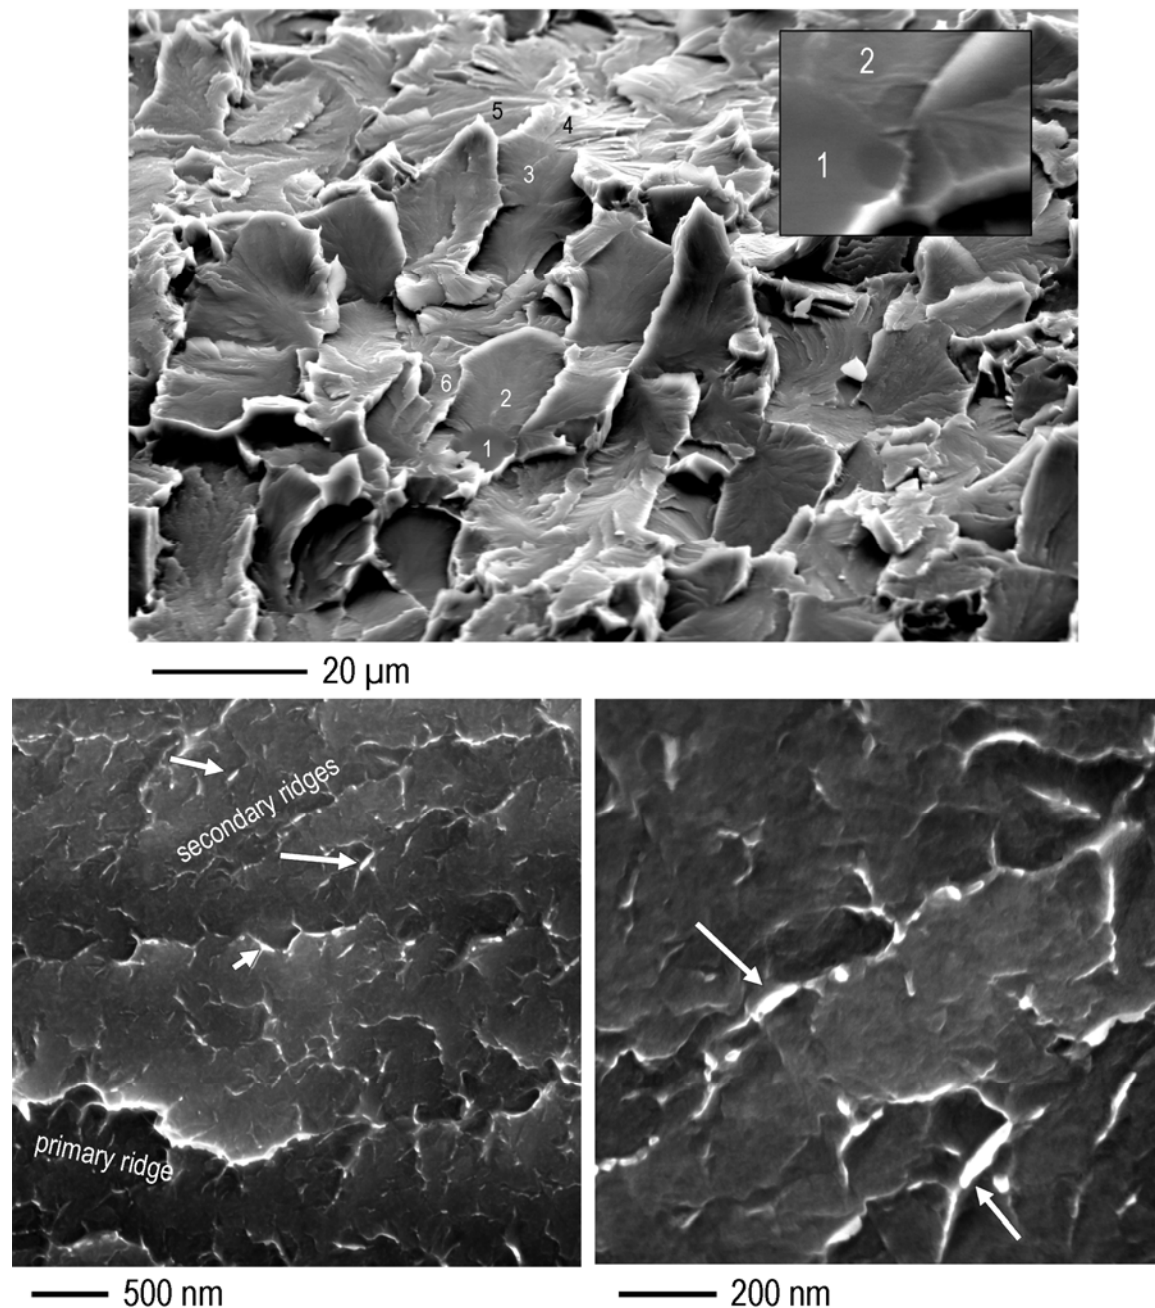
Regardless of spatial orientation, the propagation facet surfaces all had a similar appearance which is shown in the lower portion of Figure 13. This surface topography is considerably different than that observed on the continuously cycled specimen and appears ductile. The markings on the facet surface had a distinct directionality which was consistent with the macroscopic crack propagation direction although the

Of the facets analyzed at a slightly longer crack length (facets 3, 4 and 5 in Figure 13), facet 3 was crystallographically oriented for easy basal slip like those grains near the initiation site, however it fractured $\sim 15^\circ$ from (0001) with a facet normal angle of 14° . Facet 3 also had two different underlying grain orientations as evidenced by the loading direction pole figure, however when we accounted for the difference in fracture plane normal amongst the various regions on the facet where EBSD patterns were collected, the crystallographic fracture plane was similar for all data points measured. The c-axes of facets 4 and 5 are oriented only 4° and 8° , respectively, from the loading direction. However, despite the high resolved normal stress on the basal plane of grain 4, it fractured on an irrational plane that was $\sim 6^\circ$ from the loading direction while grain 5 had highest normal stress on the irrational plane near $\{10\bar{1}7\}$, yet fractured precisely on the basal plane.

Figure 13. (Top) Secondary electron image of a crack initiation site in the statically loaded specimen (H3-4). Six facets are identified which were analyzed in detail. The initiation site is shown at higher magnification in the inset. (Bottom) High resolution images showing the facet topography of typical crack propagation facets. The macroscopic crack propagation direction is from left to right. See text for information regarding arrows.

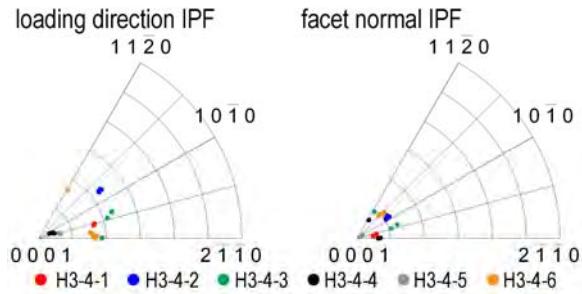
The crystallographic orientations of the initiation facet and five propagation facets (Figure 13) were studied in detail and the results have been plotted on the inverse pole figures in Figure 14. The initiation site, facet 1, had a normal that was 23° from the loading direction while the propagation facets at the smallest crack length (facets 2 and 6) had angles of 18° and 11° , respectively. With regards to the plane of fracture, facet

1 is approximately 5° from the basal plane while facets 2 and 6 have fractured on planes approximately 15° from (0001). Similar to the case of continuous cycling, the crack initiated within a grain whose [0001] direction was inclined to the loading direction ($\sim 25^\circ$). Thus, the grain in which the crack started was oriented such that there was sufficient resolved shear stress for slip on the basal plane at the applied stress. The nearby propagation facets were less inclined, however, than those surrounding the continuous cycling initiation facet. It is also noted that the first propagation facets, 2 and 6, were also in an orientation where they could deform easily by basal slip, both having their c-axes more inclined to the loading direction than the crack initiating grain. However, despite the almost certain presence of basal slip bands, the crack clearly propagated along a crystallographic plane that was inclined to the basal plane and closer to $\{10\bar{1}7\}$.

Figure 14. Results from the facet crystallography analysis on the initiation (H3-4-1) and propagation (all others) facets from the statically loaded specimen

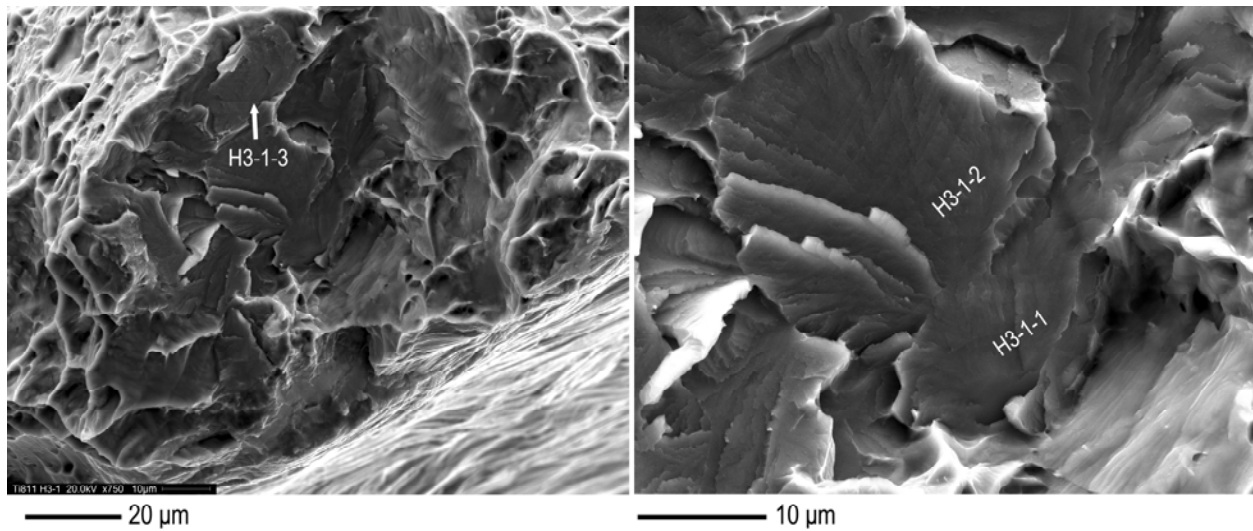
The specimen in the as-received condition that was statically loaded in 3.5 pct. NaCl exhibited surface crack initiation emanating from the scribe lines, however, none of these were directly connected to any of the faceted regions. Furthermore, there were no faceted initiations observed that appeared to be the result of surface slip band extrusions like those reported by Zhang and Vereecken [40]. There was one small region of facets (Figure 15) that was within a few microns from the surface of the specimen whose features indicated that the crack was running away from the surface of the specimen. This suggests that these facets were formed at a very small crack length after surface initiation in grains not suitably oriented for faceted crack propagation. Three of the facets from this region were analyzed in detail, labeled H3-1-1, H3-1-2 and H3-1-3 in Figure 15. All three facets were substantially inclined to the loading direction, having facet normal angles of 31° , 32° and 37° , respectively. With respect to the loading direction, the c-axis of all three grains was inclined between 40° and 47° to the loading direction (Figure 16). Similar to the case of static loading in air, all of the facet planes near the initiation site were coincident with an irrational $\{hkil\}$ plane that was inclined to the basal plane, between 6° and 14° in this case. Slip traces were evident on some facet surfaces (H3-1-2 in Figure 15, for example), however the slip traces were not parallel to the steps or ridges on the facet surfaces that were indicative of the local growth direction.

Figure 15. The facets nearest to the surface of the sample on the as-received specimen subjected to static loading in 3.5 pct. NaCl at 95 pct. of the yield strength.

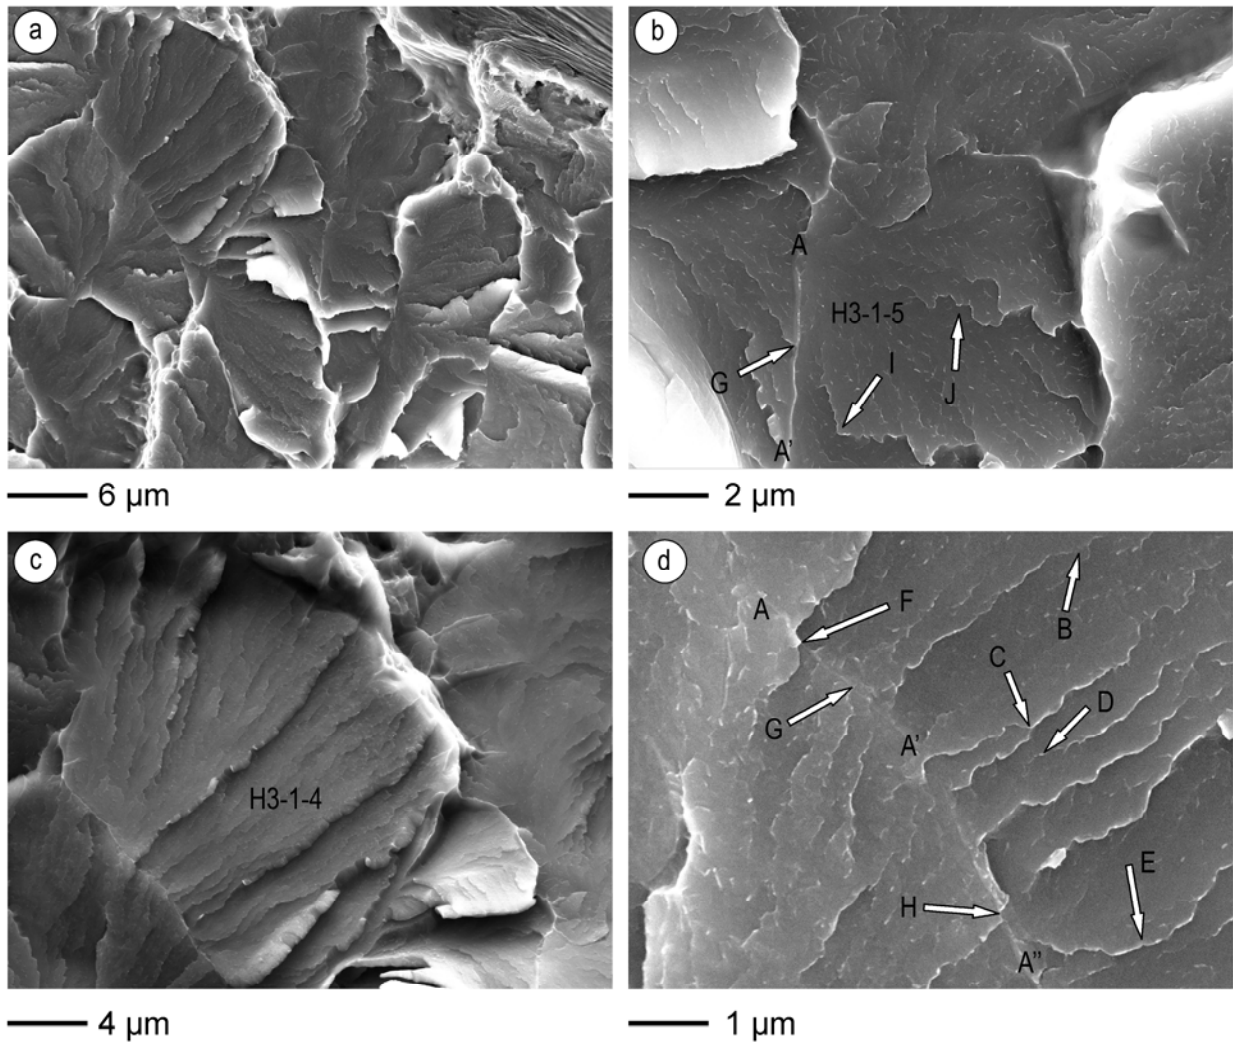
Additional propagation facets were analyzed in a different faceted region near the surface on the opposite side of the specimen where the crack was growing towards the free surface (Figure 17a). Similar to the specimen statically loaded in air, these propagation facets were typical of those observed throughout the rest of the faceted regions in this specimen. At longer crack lengths, the ridges on the facet surfaces were more similar in appearance to those in the specimen statically loaded in air except there were almost no tributaries extending from the primary ridges transverse to the primary growth direction as there were in the specimen statically loaded in air. The difference in the surface topography is most likely due to the

difference in environment at the crack tip. The facets in Figure 13 were formed before the crack was surface connected and therefore was propagating in a vacuum while the facets in Figure 17 were formed in the presence of a mildly corrosive 3.5 pct. NaCl solution. The main difference between the facets on the two specimens is the tributaries which branch out from the primary ridges on the statically loaded specimen (Figure 13), but not the 3.5 pct. NaCl solution (Figure 17). In addition, the peaks of all the ridges exposed to 3.5 pct. NaCl seemed to have been "smoothed" by the electrochemical reactions that occur at open circuit potential. On the other hand, the ridges on the facets of the specimen loaded in air (Figure 13) remain in the state in which they were formed. Examining the spatial and crystallographic orientations (Figure 16) of these propagation facets revealed that the facet normal directions were 7° and 8.7° from the loading direction. The [0001] axis of grain H3-1-4 was parallel to the loading direction, yet it fractured on a plane approximately 5° from (0001). In contrast, [0001] of grain H3-1-5 was $\sim 19^\circ$ from the loading direction with a fracture plane approximately 14° from (0001), or 1° from $\{10\bar{1}7\}$.

Between the primary ridges on the specimen tested in 3.5 pct. NaCl, there were smaller ridges approximately 100 nm to 200 nm long that also tended to align in the nominal direction of crack propagation as in Figure 17b and Figure 17d, for example. Images acquired with the TLD reveal that the ridges behave in a number of different ways compared to the steps on continuously cycled specimens [4,30]. These are illustrated by letters A through J in Figure 17b and Figure 17d which show facets H3-1-4 and H3-1-5. Some ridges are observed to get smaller until they become indistinguishable from the facet surface as indicated by letter B. The ridges are observed to interact in a number of ways at grain boundaries, which are identified by line segments A-A' and A-A'-A''. For instance, at location A', a new ridge is formed in the grain boundary whereas one ridge approaching the boundary at F gives rise to one larger ridge in the adjacent grain. However, at location G, a ridge is arrested at the grain boundary and not even a small ridge is

Figure 17. Propagation facets on the fracture surface of the as-received specimen subjected to static loading in 3.5 pct. NaCl at 95 pct. of the yield strength. Those facets analyzed in detail have been labeled with unique facet identification numbers. See text for details regarding the features identified by letters in (d).

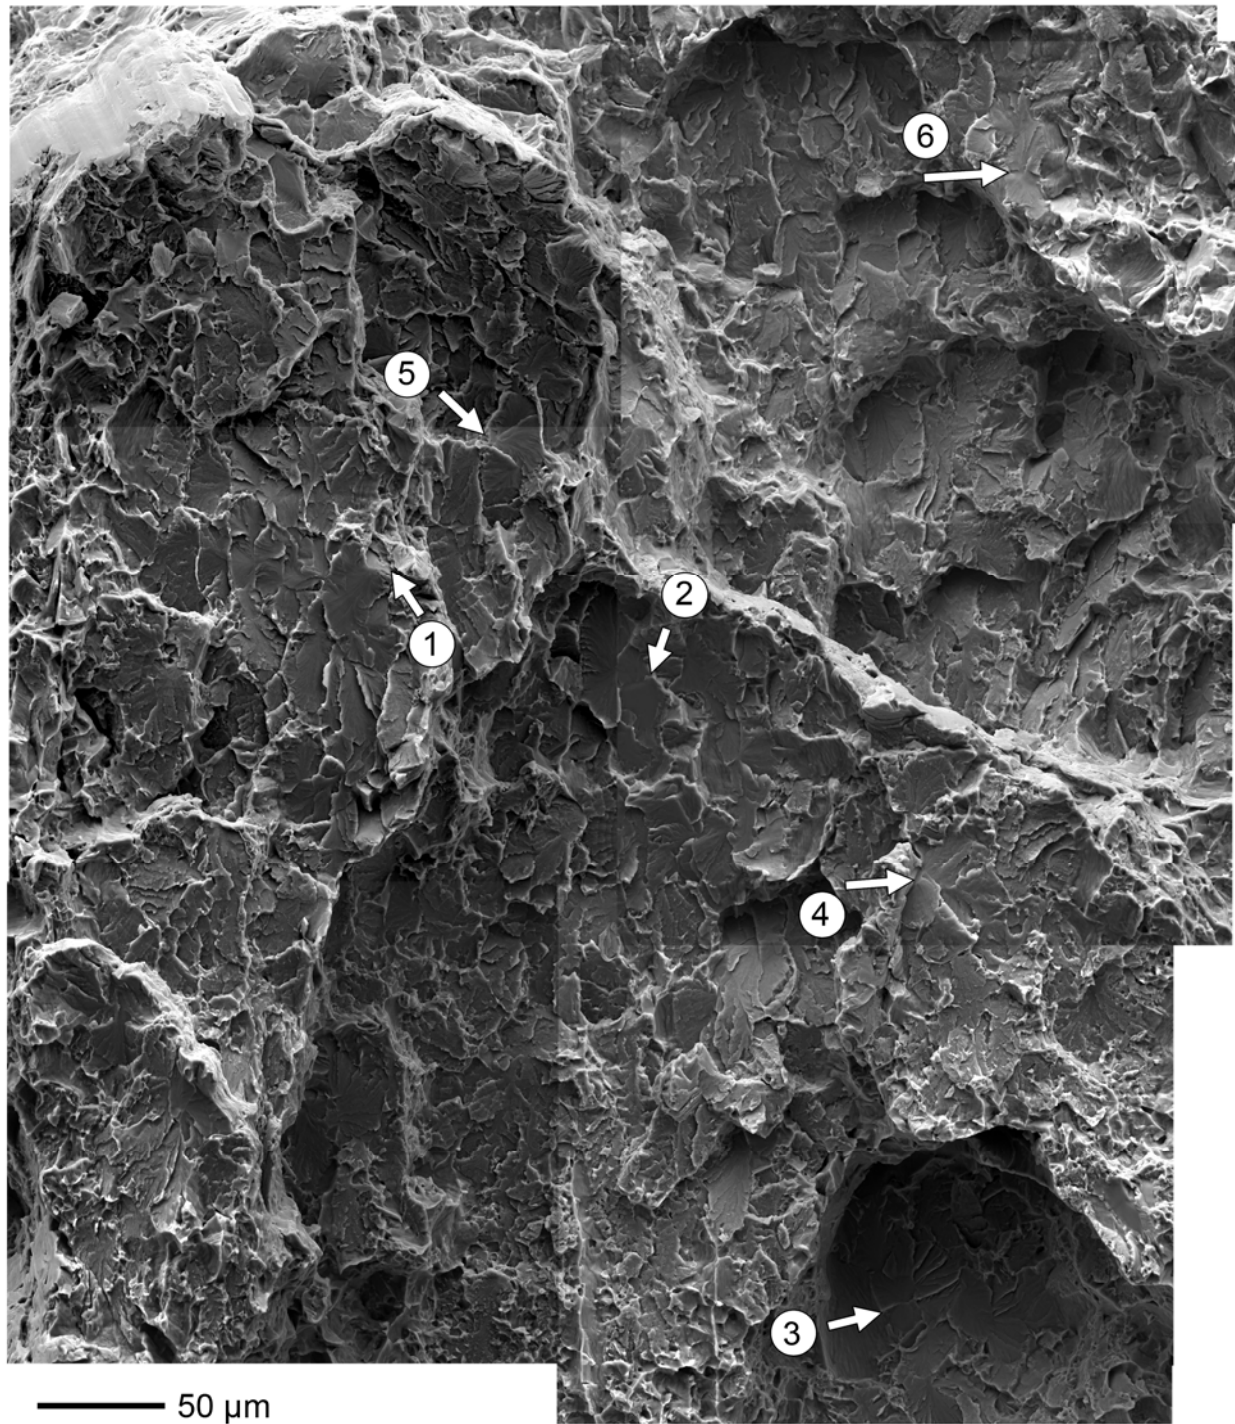
In addition to the primary and secondary initiation sites identified in the low magnification image of the fracture surface in Figure 6, another five subsurface secondary initiation sites were identified near the primary initiation site as shown in Figure 18. At least six other subsurface initiation sites were identified throughout the rest of the faceted region that extended towards the other side of the specimen, although

Figure 18. Higher magnification secondary electron montage of the region around the primary initiation site (1) which reveals several secondary initiation sites (2-6).

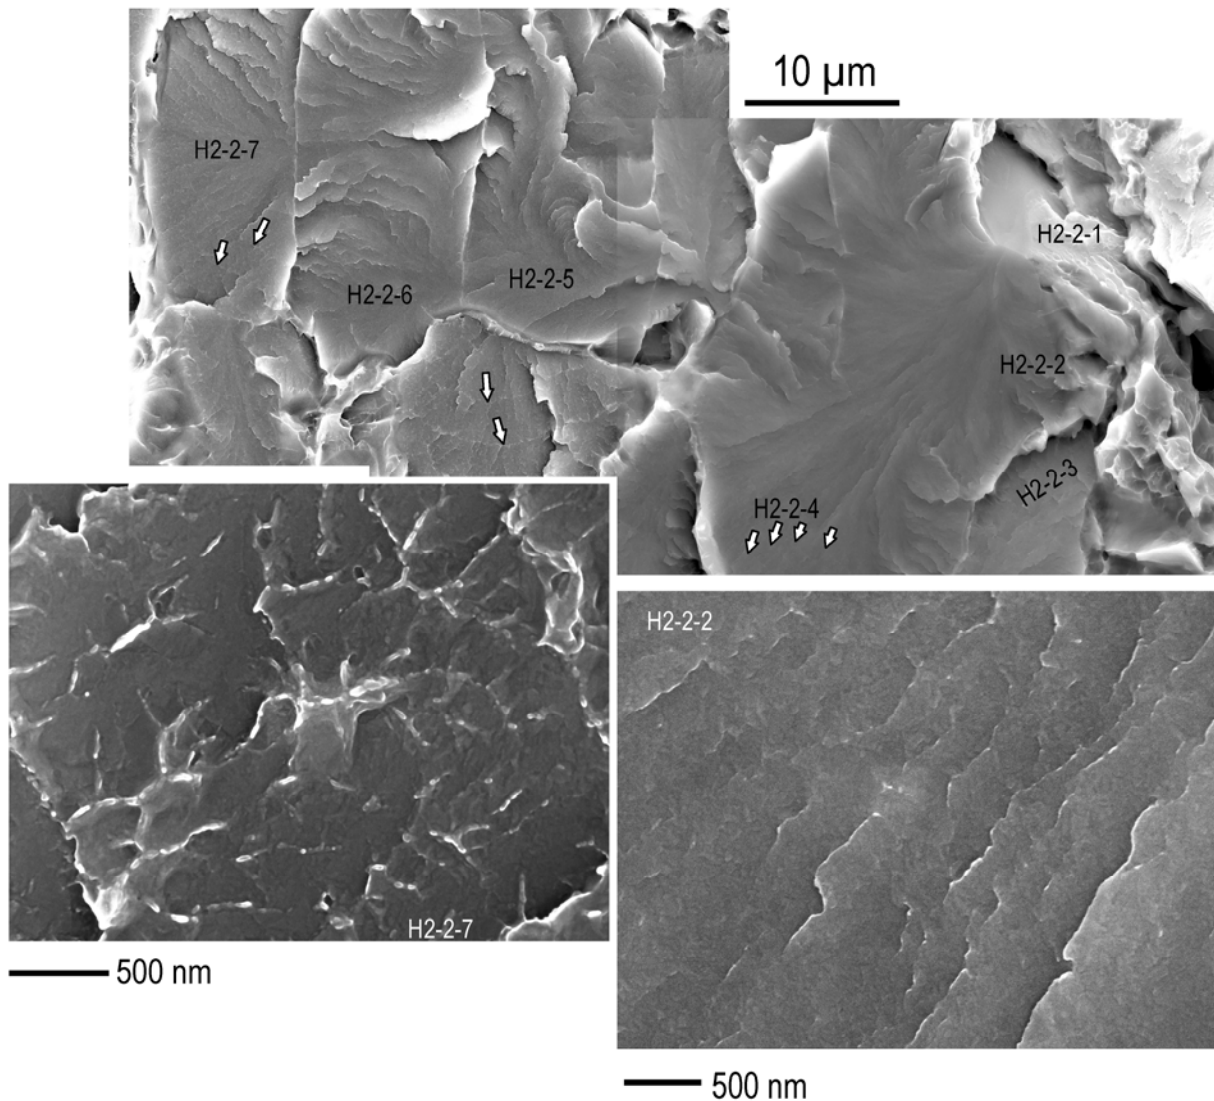
The primary initiation site (Figure 19) serves as a good example to demonstrate the necessary characteristics to be classified as an "initiation site". The term "primary" implies that the location was where the first crack formed during testing for reasons that will become apparent below while the term "secondary" only implies that the initiation event occurred after the primary one. The fractographic analysis is not able to discern the order of subsequent initiation events. This terminology is consistent with that of Uta et al. [17] and also supports their observation of multiple initiation events within a single microtextured region during a dwell fatigue test of IMI 834. The facet topography in this region is consistent with that on the specimen statically loaded in air, with ridges extending along the direction of crack propagation. These markings lead back to the intersection two facets on the fracture surface, H2-2-1 and H2-2-2, which are shown at a higher magnification in Figure 20. There were steps on the surface of facet H2-2-1 and ridges on the surface of facet H2-2-2, both leading away from the grain boundary (segment A-A'). This implies that the crack initiated at the grain boundary where these two particular planes met. It is noted that there is extremely good mating between the facet planes over the length of the boundary which suggests that this is a primary α / primary α boundary as opposed to a primary α / retained β / primary α or a primary α / retained β / transformed β boundary. After the crack initiated at the boundary, it propagated by faceted growth through the surrounding grains labeled H2-2-3 through H2-1-7 and beyond.

Figure 19. High resolution secondary electron images of the fracture surface of the dwell fatigue specimen (all at 0 deg. stage tilt). The top image shows the initiation facet (H2-2-1) which is inclined substantially to the loading axis and subsequent propagation facets (H2-2-2 through H2-2-7). The arrows in the top image identify crack front arrest marks.

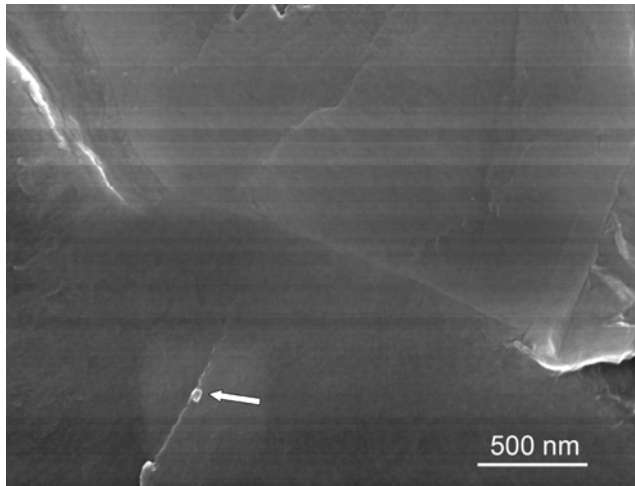
Figure 20. The intersection of facets H2-2-1 and H2-2-2 at the primary dwell fatigue crack initiation site. The arrow identifies a small particle near the first ridge formed on the first propagation facet. The composition and crystallographic structure of this feature is unknown.

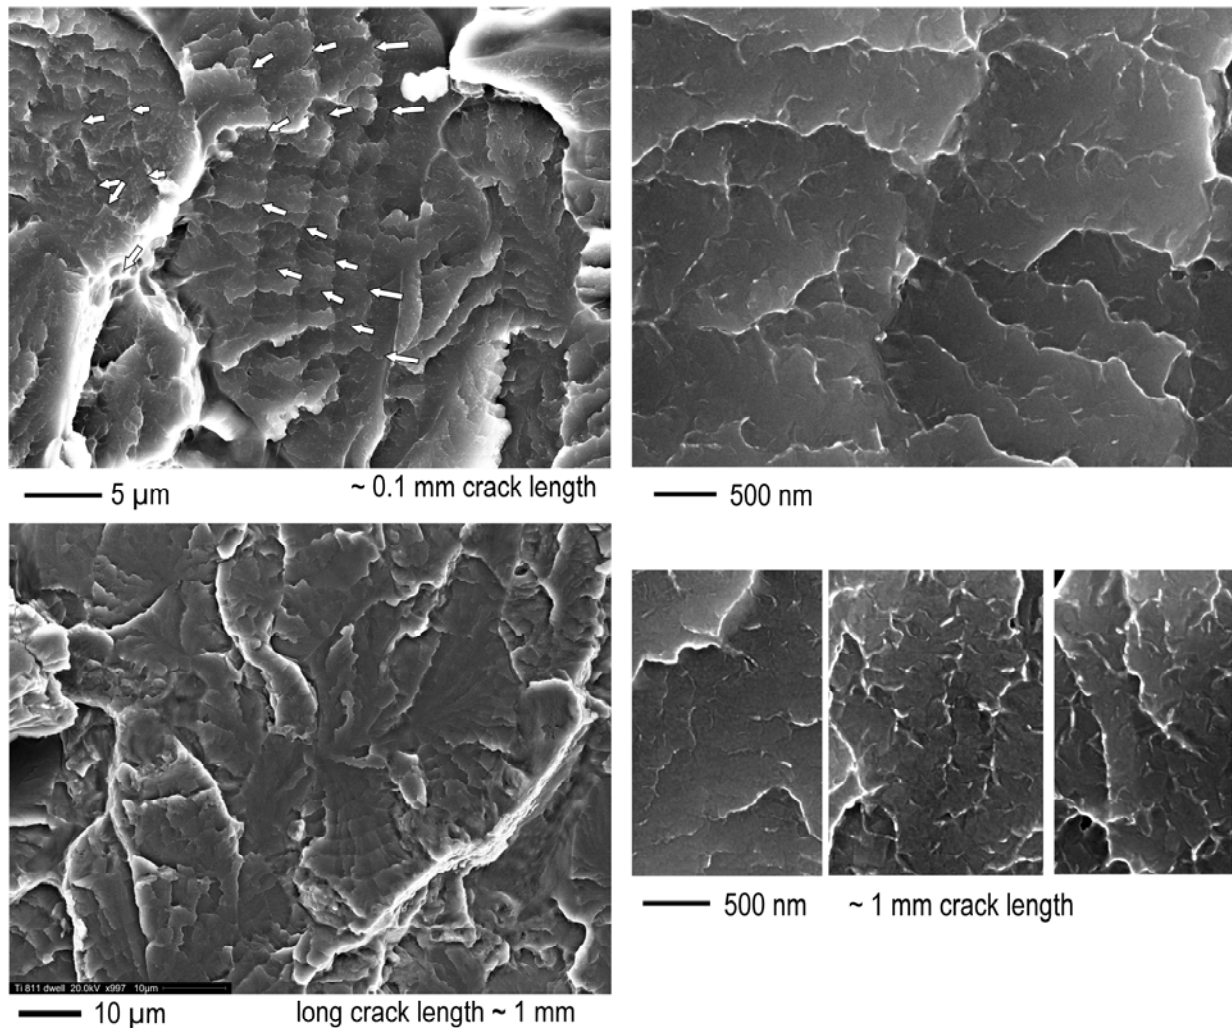
Figure 21. Secondary electron images showing very little variation among the facet surface topography as a function of crack length in the dwell fatigued specimen. A secondary initiation site is also evident in the center of the lower left image.

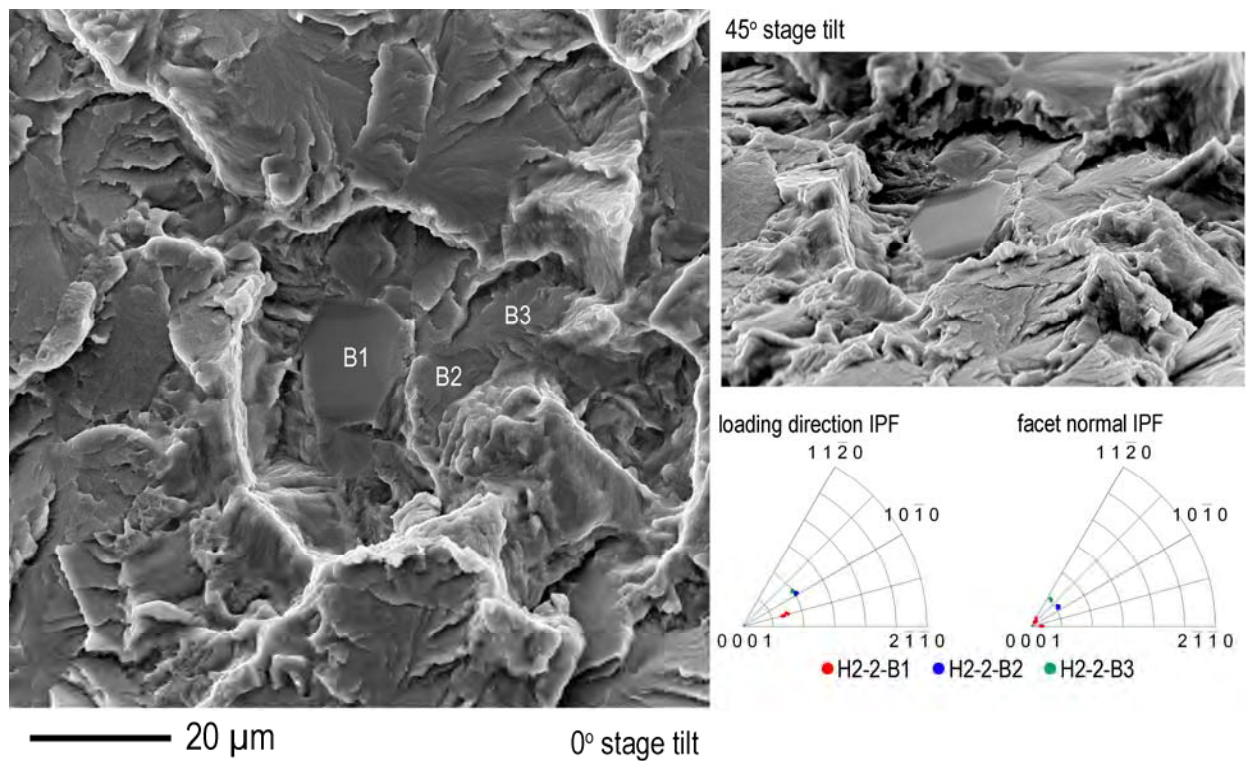
Figure 24. Secondary electron images and facet crystallography analysis of a secondary initiation site in the dwell fatigued specimen. This location is approximately 380 μm away from the primary initiation site.

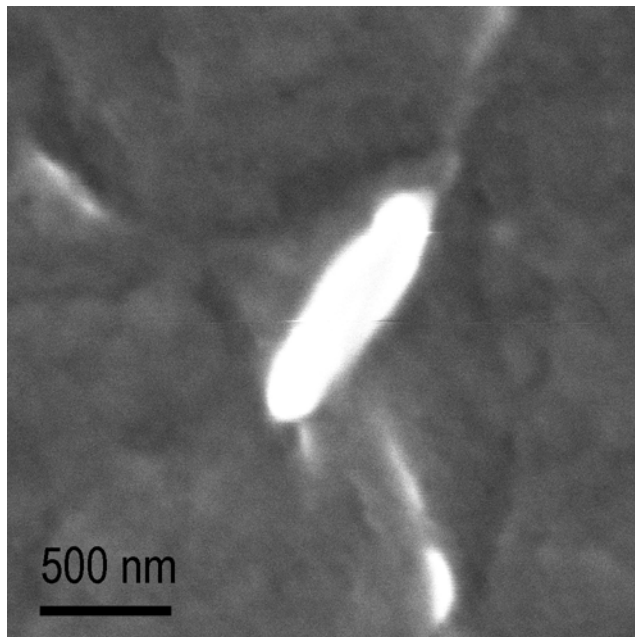
Figure 27. Secondary electron image (TLD detector, 256,000x) of a possible hydride particle from a dwell fatigue propagation facet.

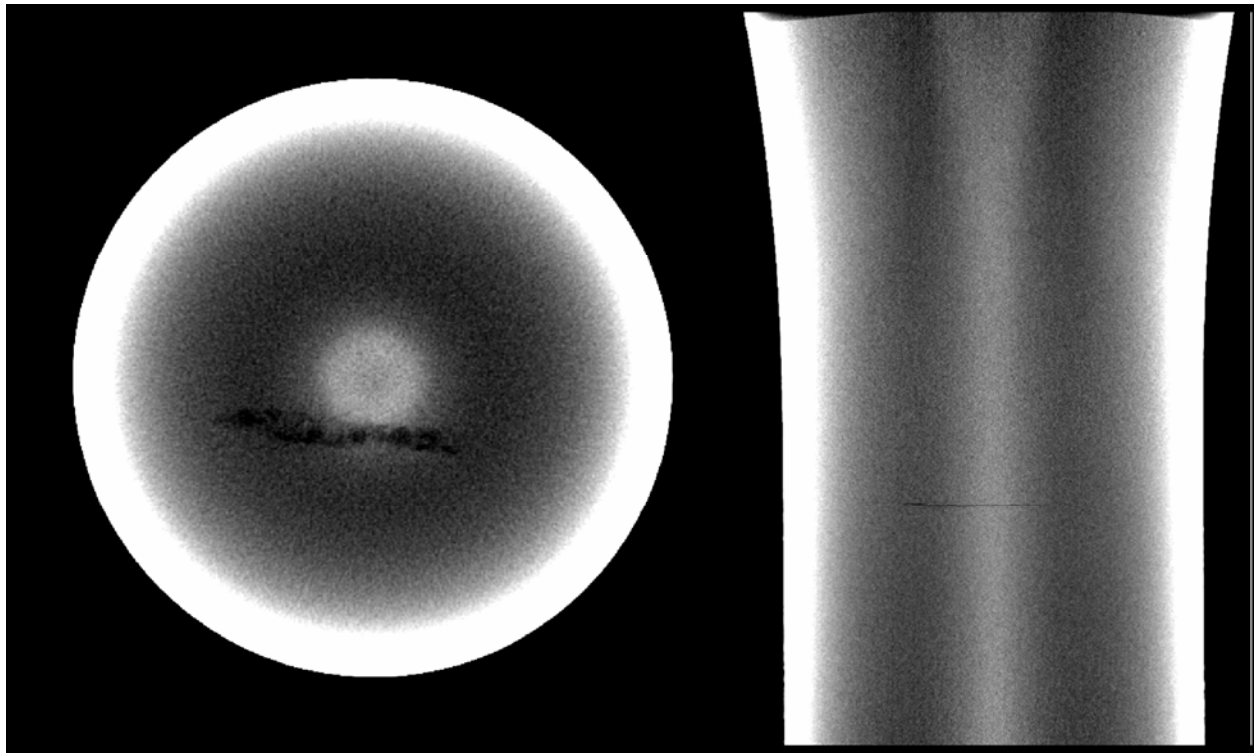
Figure 28. Two orthogonal view of an x-ray computed tomography scan of a dwell specimen which had not failed after 26k cycles.
